The Outback Gear and Drag

Rev. 10-7-2010, C.Zavatson

In the on-going effort to reduce drag, the focus turns to an issue unique to the outback gear seen on the Lancair 320/360.

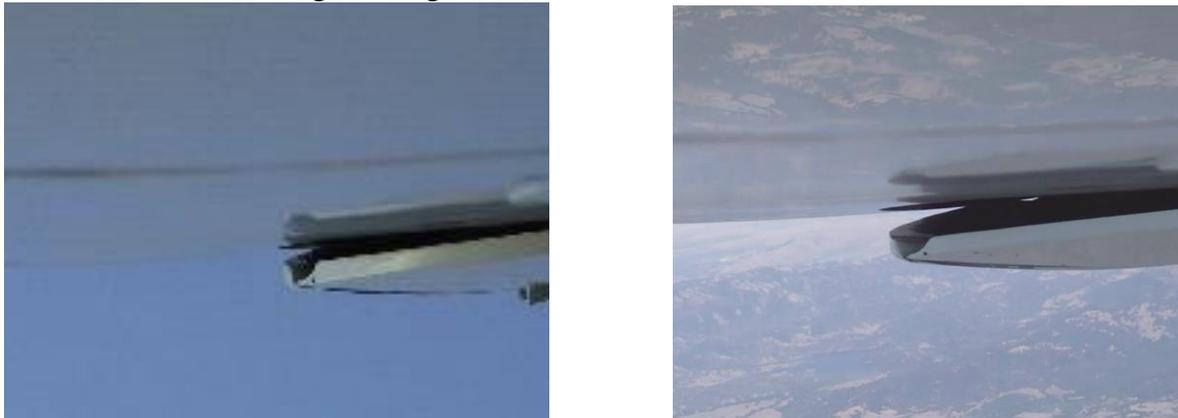
Figure 2, Original Outback Gear Doors on two different Lancair 360s

Unfortunately the larger area, long moment and the flexible fiber glass materials all contribute to the rear of the outback doors opening in-flight. The leading edge might remain retracted, but the door itself twists under load. Simply giving the doors a good yank on the ground reveals their flexibility. Air to air photos show this phenomenon, but getting a really close up view provides much more detail. In-flight footage shows the results of air flow over the door.

While open doors are not a safety issue, it represents an area of improvement in efficiency. They are a drag penalty for having such a large gap open up.

Prior to replacing the doors with a new design, a series of exploratory tests were conducted. The purpose was to isolate the source of the forces involved. The wheel well was completely sealed from the cabin. A bellows boot sealed the aileron pushrod and a composite cover was installed over the inner gear door cylinder. Next, the wheel well pressure was measured relative to ambient. This measurement revealed a strong negative pressure, indicating the doors were being pulled down by external low pressure rather than being pushed down by internal high pressure. Flow separation (and lack of pressure recovery) on the rear half of the doors was also eliminated as a root cause or contributing factor by tufting this area. The flow remained fully attached. The trailing edges of the original doors deflect downward through a twisting of the door itself. The degree of deflection is proportional to indicated airspeed, more speed equals more deflection. At cruise speed this can be on the order of an inch at the trailing edge.

The approach used to solve this problem was to utilize a three piece design and improve the stiffness of the doors themselves. The new doors are made of carbon. They are geometrically identical to the original doors but have greatly increased stiffness. The new inner gear door is about half the size of the original. This enables it to exert much greater vertical force on the overlap with the center door. The center door is attached to the main gear trailing link arm using four stand-offs. A new trailing link arm was fabricated to provide mounting tabs for the new door. The wide mounting foot print provides a solid base which further adds stiffness.

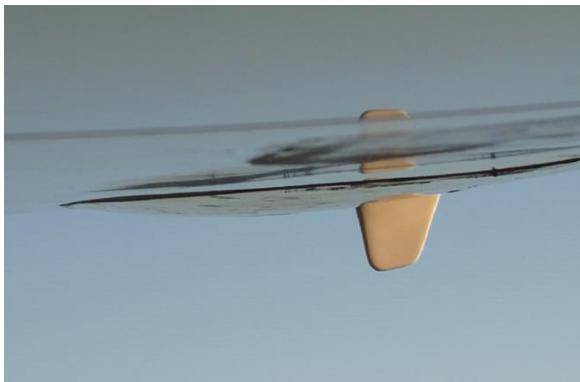
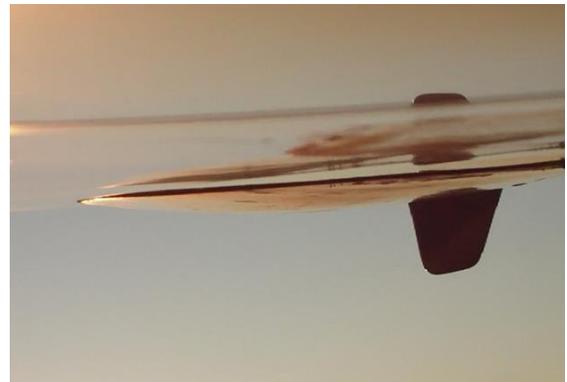
Figure 6, New Carbon Doors In-flight

Flight tests were initially conducted with just the passenger side door replaced. Once the concept was proven out, the pilot's side door was also replaced. After some adjustments, multiple test flights at ever increasing speeds have shown the doors to remain completely locked in the retracted position.

Finally, new official speed measurements were made. These were recorded at 7,500 feet, 2,500 rpm, WOT and in calm conditions. True airspeed increased from 206 to 210 KTAS. The original doors were acting much like spoiler or speed brakes. The total drag reduction is equivalent to 6% engine power.
