The Outback Gear and Drag

Rev. 10-7-2010, C.Zavatson

In the on-going effort to reduce drag, the focus turns to an issue unique to the outback gear seen on the Lancair 320/360.

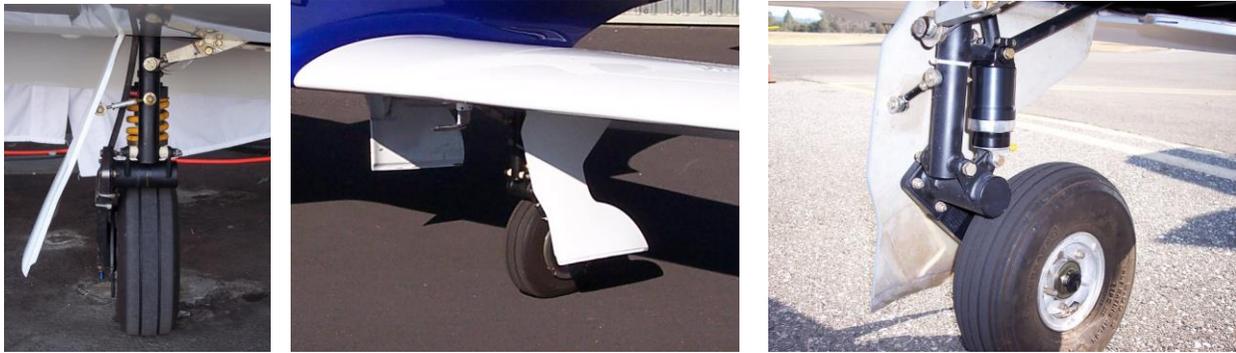
Figure 1, Photos of the “Outback Gear”

The “Outback Gear” replaced the 11.400-5 wheels with the larger and more common 5.00-5 wheels. The outback gear also brought with it changes to the landing gear doors that had some unintended consequences. The doors switched from a three piece design to a two-piece. The outback gear doors are larger and have a good deal of camber. They must ‘bump out to clear the larger wheel assembly. This introduced a few problems. The highly cambered door created a large downward force on the doors. As a two piece design, the doors depend heavily on the inner gear door cylinder to keep both doors retracted. The outboard doors are very long and have a narrow cross section near the actuation attach point. The inner gear door overlaps the outboard gear door when retracted.
